Interesting observations on stone weathering of an Indian monument by lichens*

Singh, Ajay & Dhawan, Shashi 1992. Interesting observations on stone weathering of an Indian monument by lichens. *Geophytology* 21 :119-123.

Qualitative assessment of damage caused by lichens to a 16th century stone monument, Yognarsimhaswami temple, Baggavalli, Kamataka is made. A species of *Leconora*, very commonly growing here contains large number of oxalate crystals, that have obviously been formed by reaction of oxalic acid produced by the lichen, on metallic cations of rock (substratum) minerals. Presence of lichen substances, such as atranorin in *Physcia tribacoides* and *Dirinaria consimilis*; and sekikaic acid in the latter species (in addition to atranorin) suggests, on account of their molecular structure, the metal complexing activity of these lichen products causing chelation of cations from rock minerals. Oxalate crystal formation and chelation involving metallic elements of minerals result in corrosion of the substratum, i.e., stone surface of walls or fine carvings of sculptures.

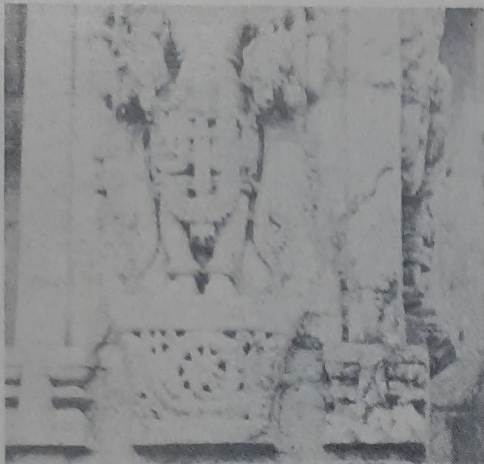
1. The temple of Yognarsimhaswami, Baggavalli.
2. Patches of *Physcia tribacoides* growing along sheltered places of the temple platform.
3. Thallus of *Physcia tribacoides* (scale = 2.0 mm).

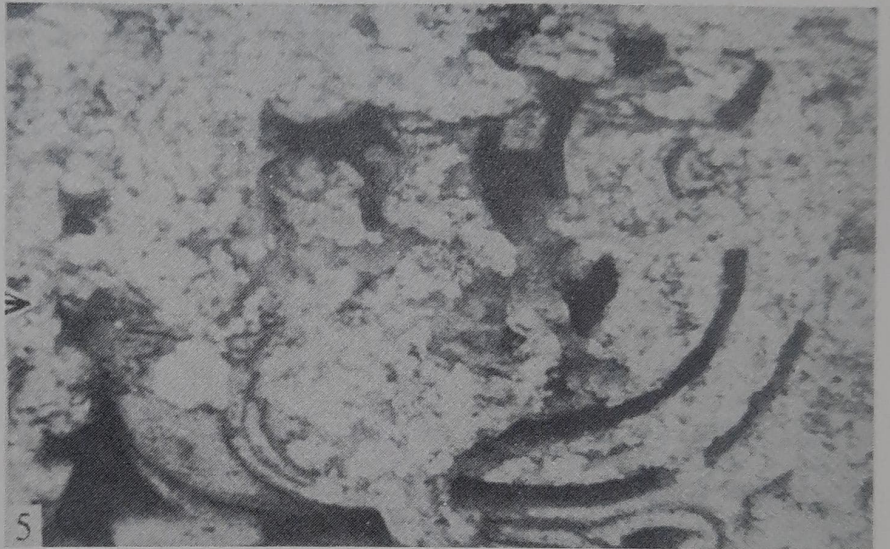
4. Part of sculptured panels at lower levels of temple wall, covered with *Lecanora* sp. 1
5. Enlargement of part of figure 4 (marked by arrow)
6. Thallus of *Dirinaria consimilis* (scale = 2.0 mm).

In the first case, the oxalic acid produced by the thallus of *Lecanora* sp. 1 (90.196A), covering considerable part of sculptured surface (Pl. 1, fig.4) seems to have acted upon the metallic component of rock minerals, resulting in extracellular deposition of oxalate crystals within the lichen thallus (Text- fig.1).

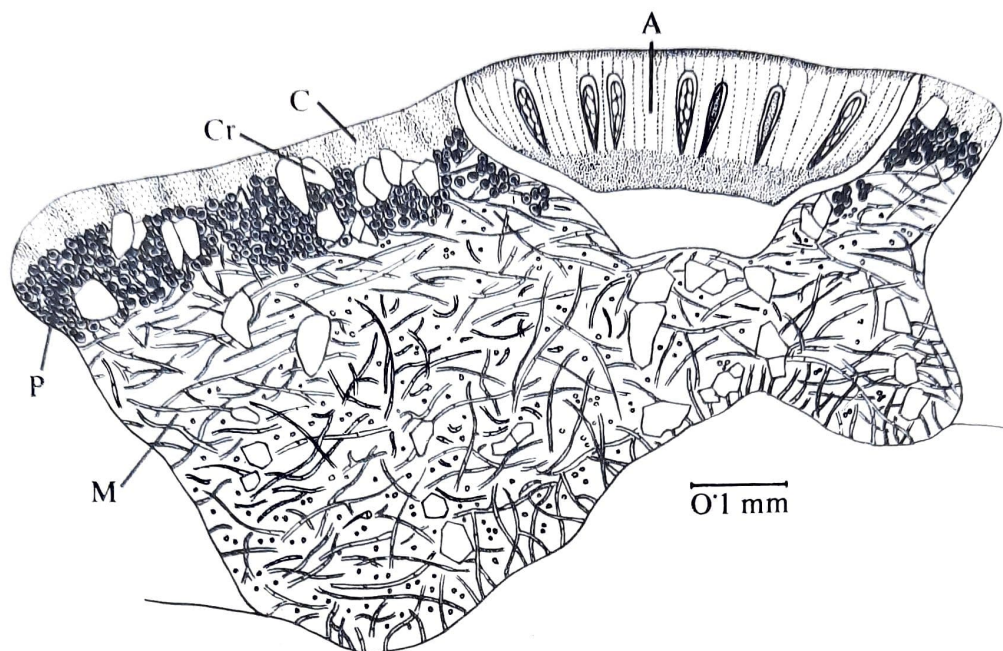
Text-figure 1. Vertical section of the thallus of *Lecanora* sp. 1. A-Apothecium
C-Corticiform layer, Cr-Crystals, P-Photobiont layer, M-Medulla.

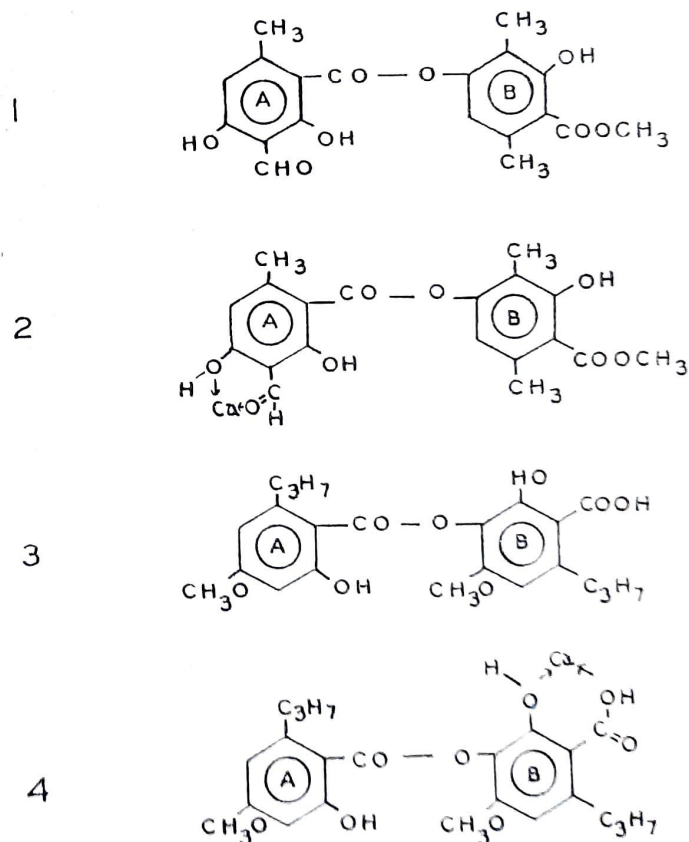
Text-figure 2. Molecular structure of atranorin. 2- Theoretical representation of metal complexing property of atranorin, 3-Molecular structure of sekikaic acid. 4- Theoretical representation of metal complexing property of sekikaic acid.

Calcium, for chelation from the rock mineral needs two pairs of electrons for its incorporation in the atranorin molecule. As visualized in the structural formula of this lichen substance one pair of electrons seems to be provided by oxygen of carbonyl of the aldehyde group (-CHO) in the ring A and the other from oxygen of one of the hydroxyl groups (-OH) in the vicinity within the molecule (Pl.1, figs 1,2 ; Text-fig.2).

In case of sekikaic acid the presence of carboxylic group (-COOH) is in all probability responsible for chelation of calcium from rock minerals. (Pl. 1, figs 3,4; Text-fig. 2). Based on the work of Schatz *et al.* (1954), Hale (1974) reproduced the theoretical mechanism for chelation of calcium by lecanoric acid, where the same group (-COOH) is supposed to bring about metal complexing process.
